High-Risk Flood Control Dams on Difficult Soil Foundations

HIGH-RISK FLOOD CONTROL DAMS ON DIFFICULT SOIL FOUNDATIONS

Addicks and Barker Dams are two flood risk management structures owned and operated by the U.S. Army Corps of Engineers (USACE) and recently classified as extremely high risk. These dams were built in the 1940's in west Houston, Texas, upstream of a densely populated metropolitan area. The dams consist of 11 and 13 miles of rolled earth embankments, outlet structures with five barrel conduits, and uncontrolled spillways at both ends of both dams. The original design of both dams provided for four of the five outlet conduit barrels to be ungated, permitting a combined uncontrolled discharge from both dams of 15,700 cubic feet per second into Buffalo Bayou. Due to urban development throughout the 1940s and 50s, all conduit barrels of both dams were gated by 1963 to allow restricted discharge flows into Buffalo Bayou during normal operating conditions.

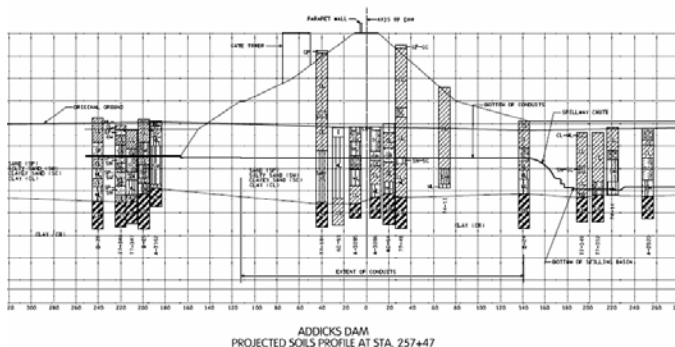
Figure 6 - Addicks Dam Soils Profile

Outlet Works Geology, Addicks Dam. At the outlet works for Addicks Dam, the upper stratum of sandy, silty, low plasticity clay extends to the depth, as indicated above, of about 10 to 15 feet, or to about the depth of the original excavation for construction of the outlet works. This upper stratum is underlain by interbedded low plasticity clay (i.e., CL – including silty clay and sandy clay), silt (i.e., ML – including rock flour, and silty and clayey very fine sand with slight plasticity), and sand (i.e., SP, SM, & SC – including silty and clayey sand, and poorly graded sand). This interbedded stratum is highly variable horizontally as well as vertically. The erodible fine sand, silty fine sand, sandy silt, and silt occurs in interbedded layers and pockets throughout the stratum. This interbedded stratum extends to a depth of about 30 feet and overlies high plasticity clay. The lowest stratum consists of high plasticity clay with little silt or sand. A composite presentation of the soils profile and phreatic surface with key boring logs at the outlet works for Addicks Dam is shown as Figure 6.

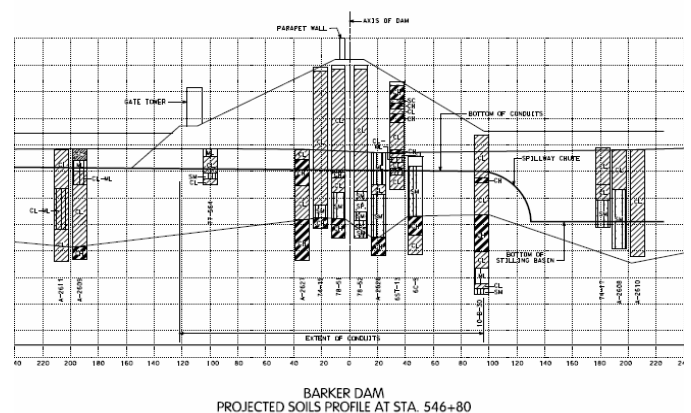
Figure 7 - Barker Dam Soils Profile

Outlet Works Geology, Barker Dam. The geologic conditions at the outlet works for Barker Dam follows the general description for the damsites of Addicks and Barker Dams, but appears to consist of less sand and silty sand than at the outlet works for Addicks Dam. The upper stratum of sandy, silty, low plasticity clay extends to the depth of about 10 to 15 feet, or to about the depth of the original excavation for

construction of the outlet works. This upper stratum is underlain by interbedded low plasticity clay, silty clay, sandy clay, silt, clayey silt, sandy silty, clayey sand, silty sand, and fine sand. This interbedded stratum is highly variable horizontally as well as vertically. The erodible fine sand, silty fine sand, sandy silt, and silt occurs in interbedded layers and pockets throughout the stratum. The sand below the outlet works at Barker Dam was encountered deeper in this interbedded layer than encountered at Addicks Dam. This interbedded stratum extends to a depth of about 30 feet and overlies high plasticity clay. The lowest stratum consists of high plasticity clay with little silt or sand. At the outlet works for Barker Dam, silt and sandy was encountered below the high plasticity clay. A composite presentation of the soils profile and phreatic surface with key boring logs at the outlet works for Barker Dam is shown as Figure 7.
